TECHNICAL REPORT REMR-CO-3

**CASE HISTORIES OF CORPS BREAKWATER
AND JETTY STRUCTURES**

Report 8

LOWER MISSISSIPPI VALLEY DIVISION

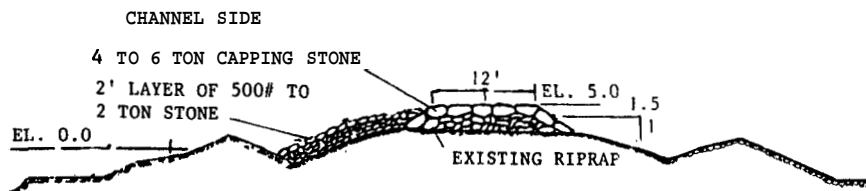
c. South jetty capping and channel slope stone, 1962

Figure 4. Typical design sections of Mississippi River Gulf outlet jetties

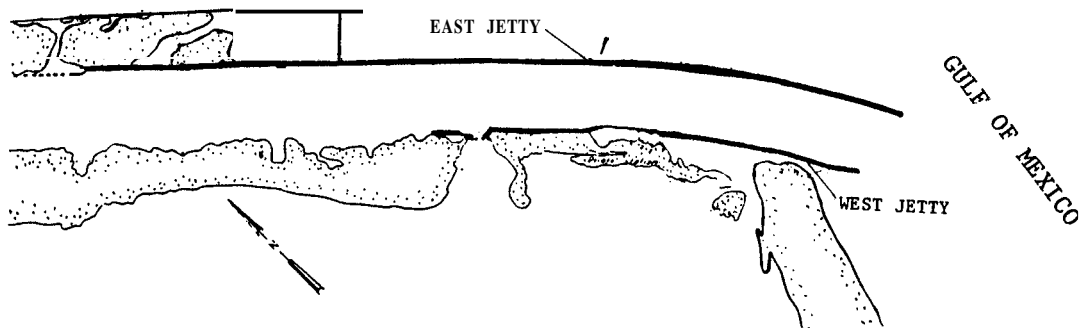
Figure 7. Plan view of South Pass jetties, 1951

Date	Construction and Rehabilitation History
1875- 1882	<p>East and west jetties, 11,170 and 7,550 ft long, respectively, were constructed to provide protection and minimize maintenance dredging for a 26- by 200-ft channel from the Gulf of Mexico to the Mississippi River via South Pass (Figure 7). The jetties were built parallel, 1,000 ft apart curving slightly to the southwest, and terminated in water about 15 ft deep. The east jetty extended about 200 ft past the west jetty seaward end. The jetties were built on a base of fascine mattresses buttressed against rows of creosoted timber piles. The mats were sunk in place by accumulating sediment and addition of riprap stone. Multiple layers were placed in this fashion with narrower mats placed in successive layers up to about flood tide level. The mats were constructed of brush and timber of various sizes, bound together, from 30 to 60 ft wide, 75 to 100 ft long, and 2 to 2.5 ft thick. Timber cribs were placed at 100- to 200-ft intervals along the seaward several hundred feet of each jetty, providing additional protection and strength. The cribs consisted of timber piles laid in alternate horizontal courses, crossing each other at right angles. The piles in the floor courses were placed in contact with each other, and those of the upper courses were from 5 to 7 ft apart, thus forming compartments from 4 to 6 ft square. The cribwork was held together with metal connectors and sunk by filling the compartments with stone. The cribs were from 25 to 70 ft long, 15 to 20 ft wide, and 5 to 15 ft in height. (Depending on water depth, the tops were at about flood tide level.) Most of the cribs were placed on either side of the jetty mats (i.e., river or sea side). During 1881-1882 additional crib work was placed mostly on the east jetty landward of the existing cribs. Concrete cap blocks (cast in place) were placed along 5,430- and 2,750-ft-long sections at the seaward ends of the east and west jetties, respectively. The cap blocks were from 4 to 12 ft wide (widest at seaward ends), 20 to 50 ft long, 3 to 5 ft high, and placed atop a 1- to 2-ft-thick layer of riprap stone. In addition, the east jetty had a parapet wall, built partly of mortared stone and partly of concrete, placed on top of the cap blocks. The wall was from 3 to 4 ft wide and 2 to 4 ft high with original top elevations varying from 4.5 to 6.8 ft above flood tide level. The original top elevations of the remaining capped jetty sections were typically from 2 to 3 ft above flood tide level. Initial settlement of the concrete cap sections varied from 0.1 to 0.7 ft/yr with an average of 0.30 ft/yr for both jetties. Figure 8 is an 1880 cross section of the seaward end of the east jetty. During September 1882 approximately 3,000 ft of the east jetty cap was damaged during a passing hurricane.</p>

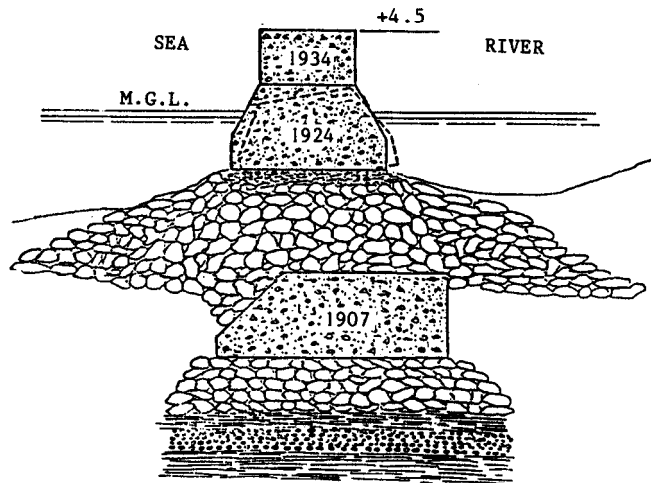
a. Cumulative work up to 1937 at 180+00

Figure 13. Southwest Pass east jetty cross sections

1924- 1937	During this period the jetties were maintained by placing concrete capping and riprap stone (usually as a base for capping). As a result of continued jetty subsidence, capping was required to maintain flow between the jetties. During this period, most sections of both jetties were capped twice with roughly 70,000 lin ft of concrete placed over approximately 32,000 lin ft of active jetty. (Landward ends were essentially landlocked and required no additional work.) Concrete was placed to an elevation of +4.5 ft mhw (or +5.5 ft mgl) in lifts typically 3 to 4.5 ft high. Widths of the cap varied from about 6 ft at the seaward ends to 3 ft at the landward ends. The total cumulative cost for capping and stone was \$1,170,000. In 1937, additional spur dikes were placed along the outer 10,000 ft of the jetties, reducing the effective channel width to about 1,400 ft. This addition was done in an effort to entirely eliminate maintenance dredging. Figure 13a is an east jetty cross section of cumulative work done up to 1937 in the general vicinity of 180+00.

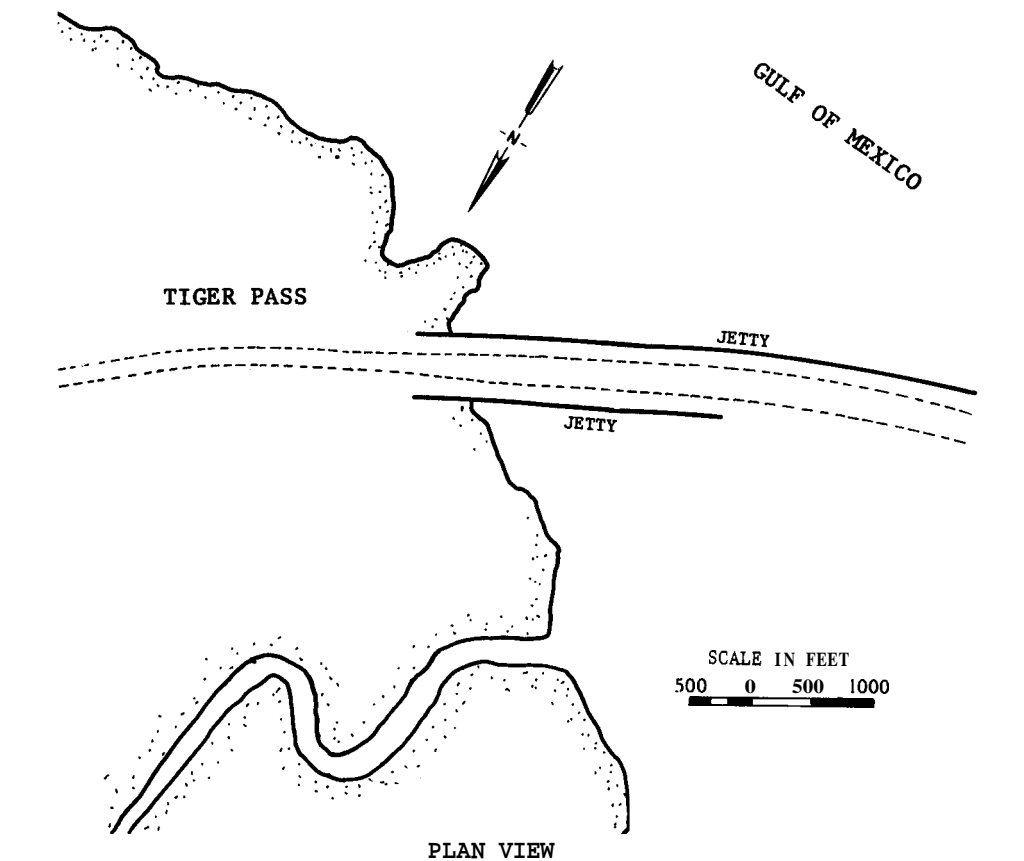
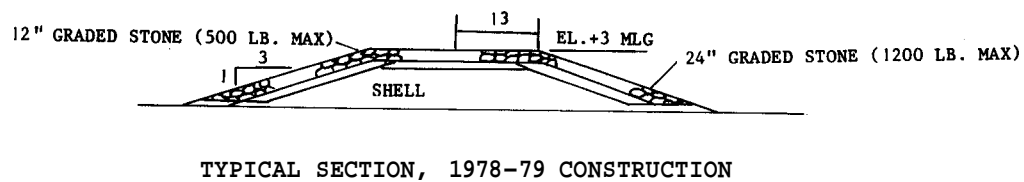
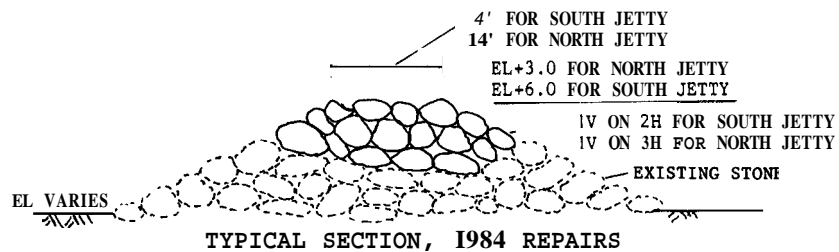
Figure 16. Plan view of Tiger Pass jetties and typical cross sections

Date(s)	Construction and Rehabilitation History
1978- 1979	<p>Two parallel rubble-mound jetties were built at the entrance to Tiger Pass (Figure 16) in order to reduce the amount of maintenance dredging required for safe navigation. These jetties were part of navigation improvements which included similar jetties at the entrance to Baptiste Collette Bayou (Figure 2), also built during this time. These waterways provide a shorter navigational route between east and west gulf waters and are used primarily by smaller vessels. The north and south jetties were 4,700 and 2,700 ft long, respectively, and spaced 540 ft apart with a 17- by 250-ft channel between them. The north jetty extended 2,000 ft past the seaward end of the south jetty. The design cross section (Figure 16) had a crest elevation of +3 ft mlg, a crest width of 26 ft, and 1V:3H side slopes. Shell material was used as core and bedding material (1-ft minimum thickness). A 1-ft-thick layer of graded "c" stone (500-lb maximum) was placed on the core side slopes followed by a 2-ft-thick layer of graded stone (1,200-lb maximum) placed on the side slopes and crown. Plastic filter fabric was placed at four test sections (two per jetty) prior to placing the shell and stone. Two 500-ft sections were at the seaward ends of the jetties and the remaining two (500 and 1,000 ft long on the north and south jetties, respectively) begin 1,000 ft from the landward ends and extend seaward. Test sections were subdivided into 250-ft reaches, in which different tensile strength fabric was placed or the design section was modified ("c" stone omitted on two reaches). Settlement plates were placed at 80- to 90-ft intervals within the test sections and 500-ft intervals elsewhere. These were placed to monitor settlement and effectiveness of the test sections. The jetties were built on top of mostly soft clays and were expected to settle 2 ft. For this reason, the south jetty, which eventually was to be built up to +6 ft mlg with graded stone (5,000-lb maximum) was to be constructed in two phases, with the portion above +3 ft mlg to be built at a later date. Prior to jetty construction, existing elevations were from +3 to -6 ft mlg. The total construction cost was \$2,085,000 using 31,500 sq yd of plastic filter fabric, 76,400 cu yd of shell material, and 105,200 tons of graded stone. A late 1979 inspection indicated that the jetties had what appeared to be large amounts of differential settlement and already constituted a maintenance problem,</p>

1984- 1985	<p>Repairs were made to both jetties. The south jetty was raised with graded stone (5,000-lb maximum) to an elevation of +6 ft NGVD, a 4-ft crown width, and 1V:2H side slopes. The north jetty was repaired with graded stone (1,500-lb maximum) to an elevation of +3 ft NGVD, a 14-ft crown width, and 1V:3H side slopes (NGVD datum approximately 0.5 ft above mlg datum). Raising the south jetty was the second</p>
